**NASA CONTRACTOR
REPORT**

**(CAVITATION DAMAGE OF MECHANICAL
PUMP IMPELLERS OPERATING IN
LIQUID METAL SPACE POWER LOOPS)**

by R. S. Kulp and J. V. Altieri

Prepared under Contract No. NAS 3-2541 by
PRATT & WHITNEY AIRCRAFT DIVISION
UNITED AIRCRAFT CORPORATION
Middletown, Conn.

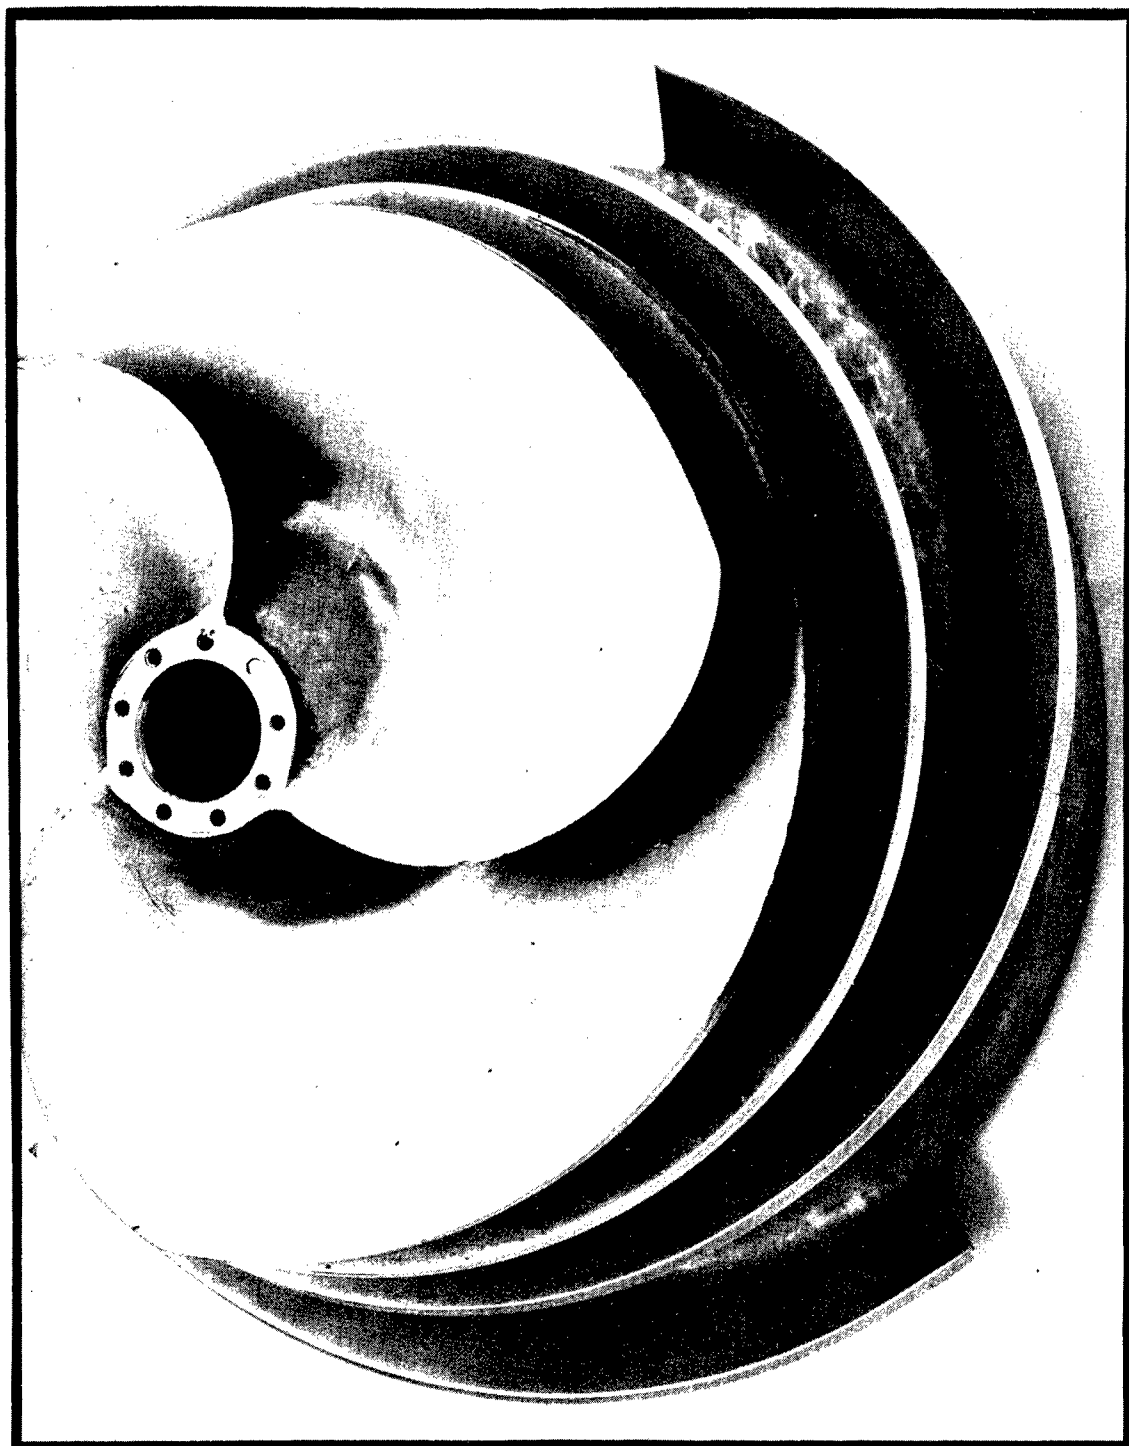
FIG 41

Upon completion of the pump tests and orifice calibrations, the turbopump was removed for disassembly and inspection. Visual inspection of the RI-7C3 impeller revealed scoring marks on the impeller (Fig. 41) and scroll insert (Fig. 42) where the two had contacted during the test. Analysis of the probable cause of rubbing contact led to the conclusion that it was caused by synchronous transients of vibration set up in the pump during tests of the 1.97 inches diameter orifice which cavitared violently. (The accuracy of this analysis is questionable in light of the liquid metal test results described in Section VIII.) The score marks were smoothed off, but not entirely eliminated before reassembly of the turbopump for the liquid metal test.

OVER-ALL VIEW OF LOCALIZED SCORING ON IMPELLER
AFTER WATER TEST IN TURBOPUMP

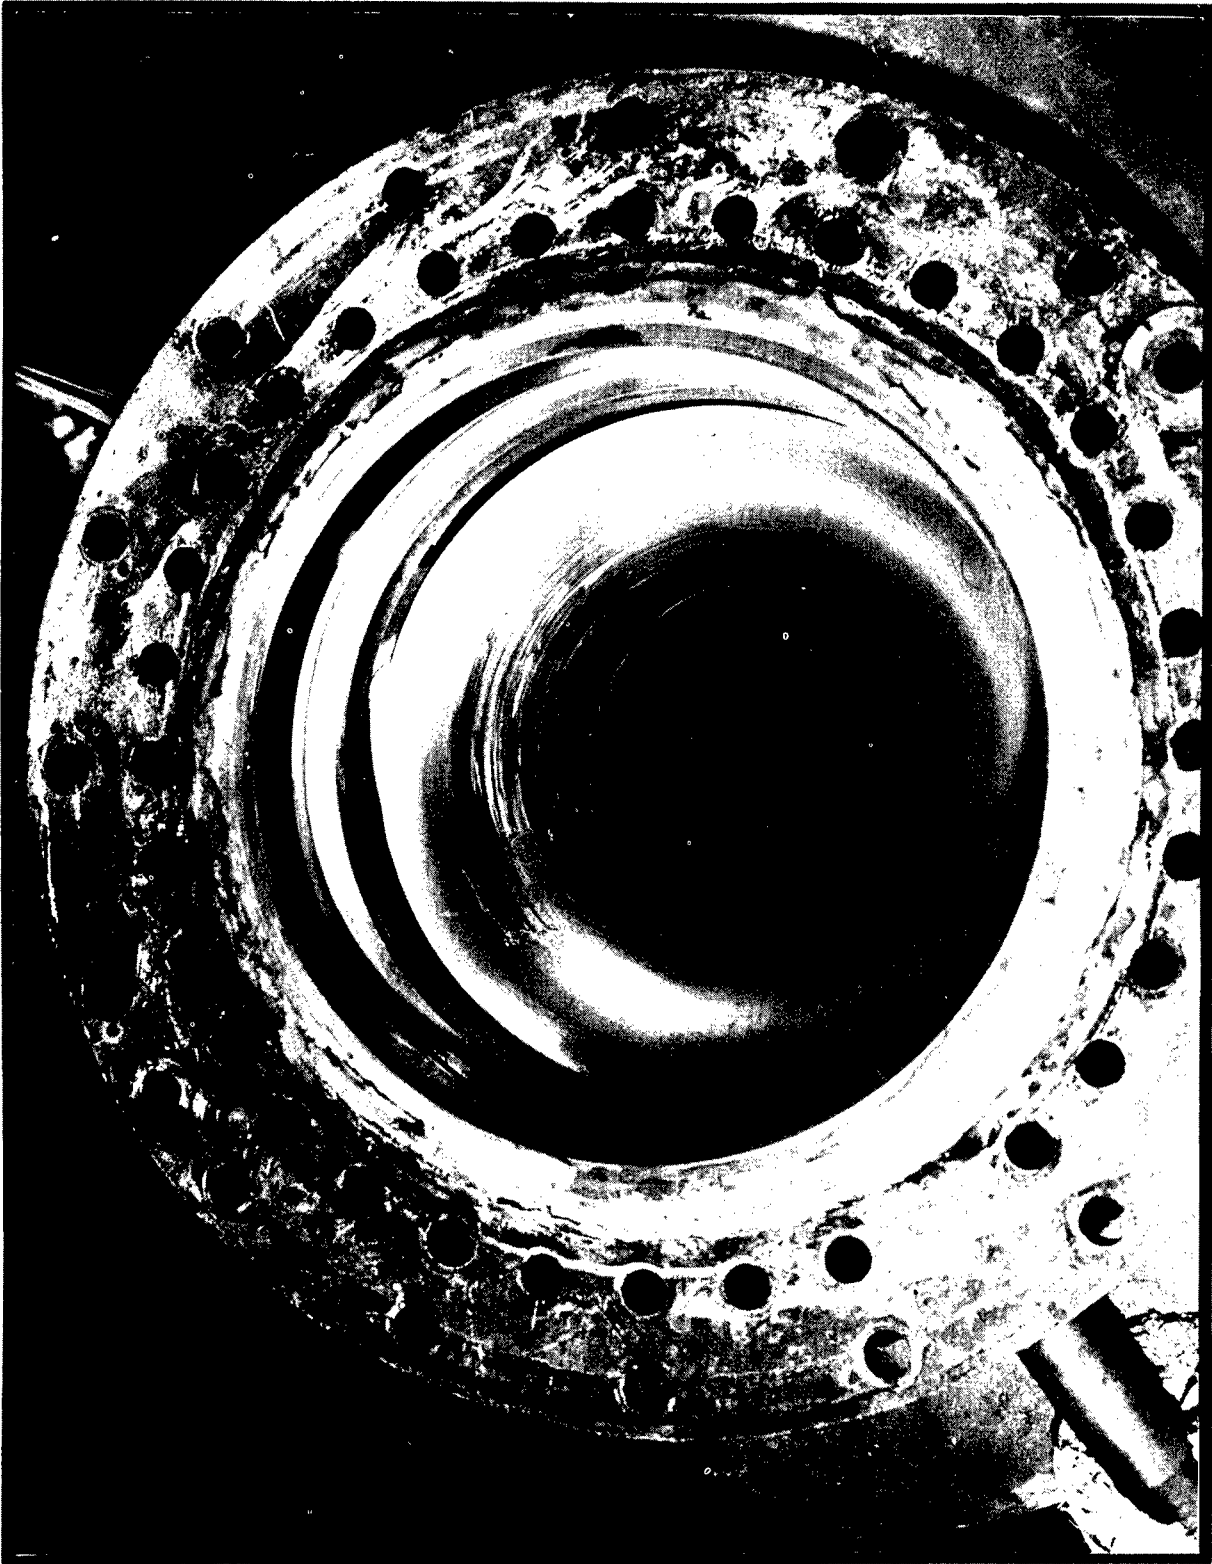
FIG 51

RUB MARKS ON SCROLL ADAPTER

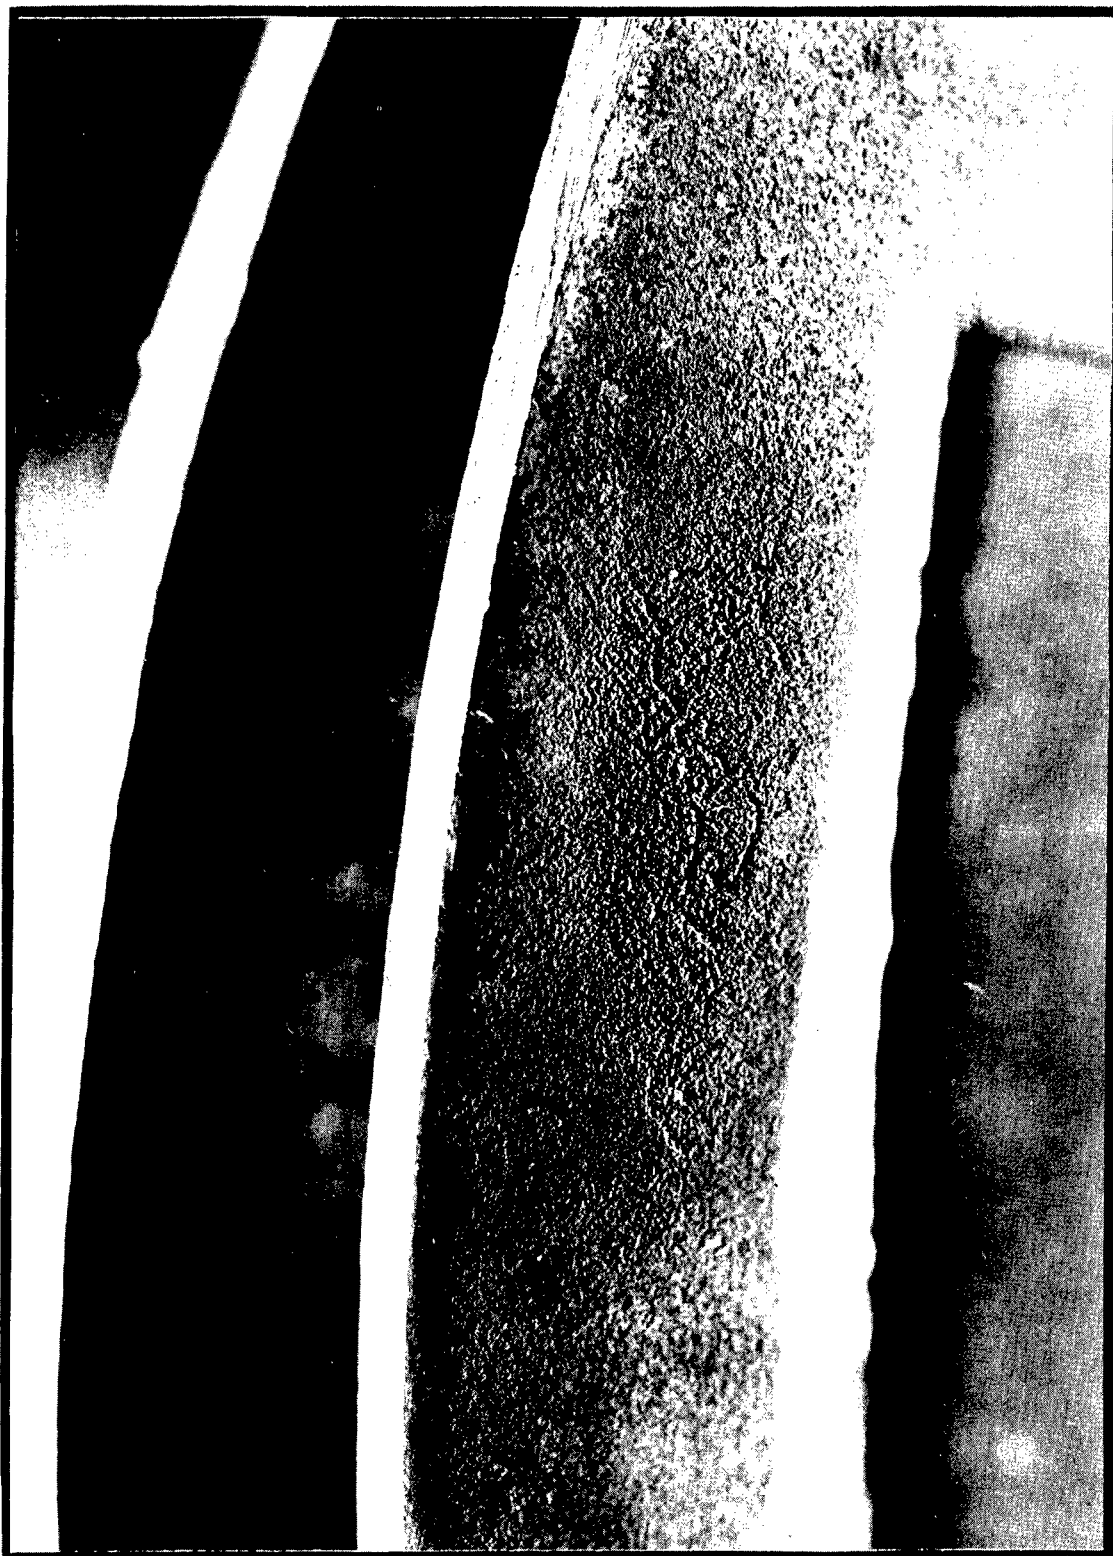
FIG 54

The principal areas of cavitation damage were located on the pressure surfaces of the vanes in the rear channels. These areas are shown in Figs. 54, 55, and 56. An area of secondarily induced cavitation damage was found on the suction surface of vane 2 and is shown in Fig. 57.

CAVITATION DAMAGE ON VANE 1

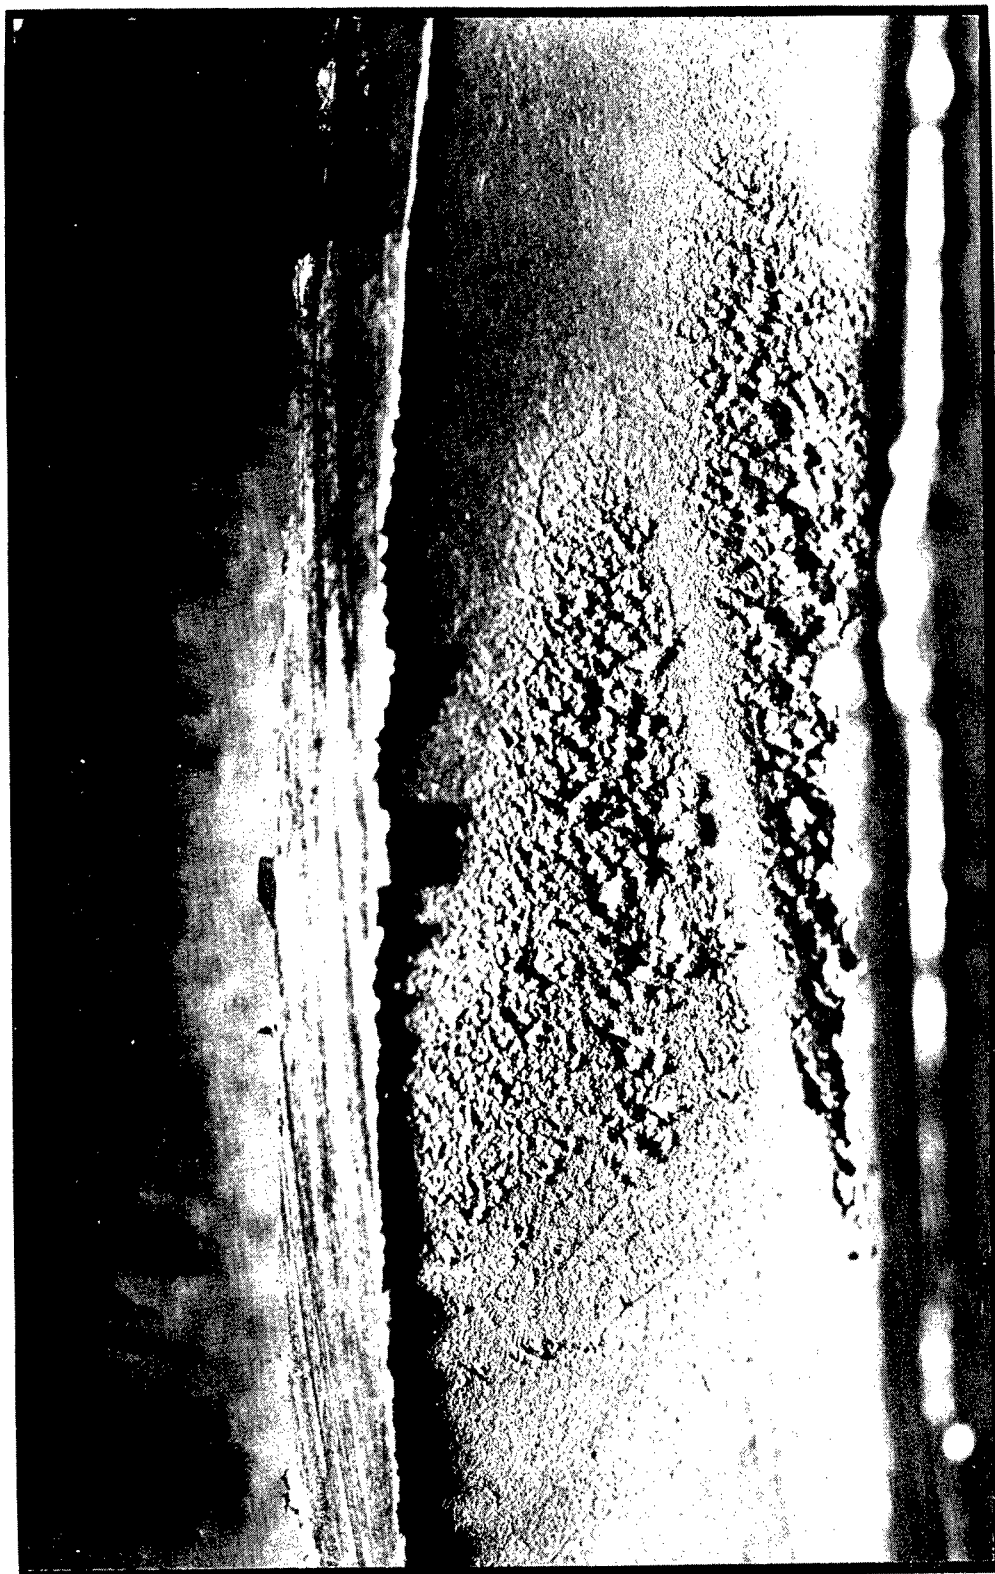
FIG 55

CAVITATION DAMAGE ON VANE 2

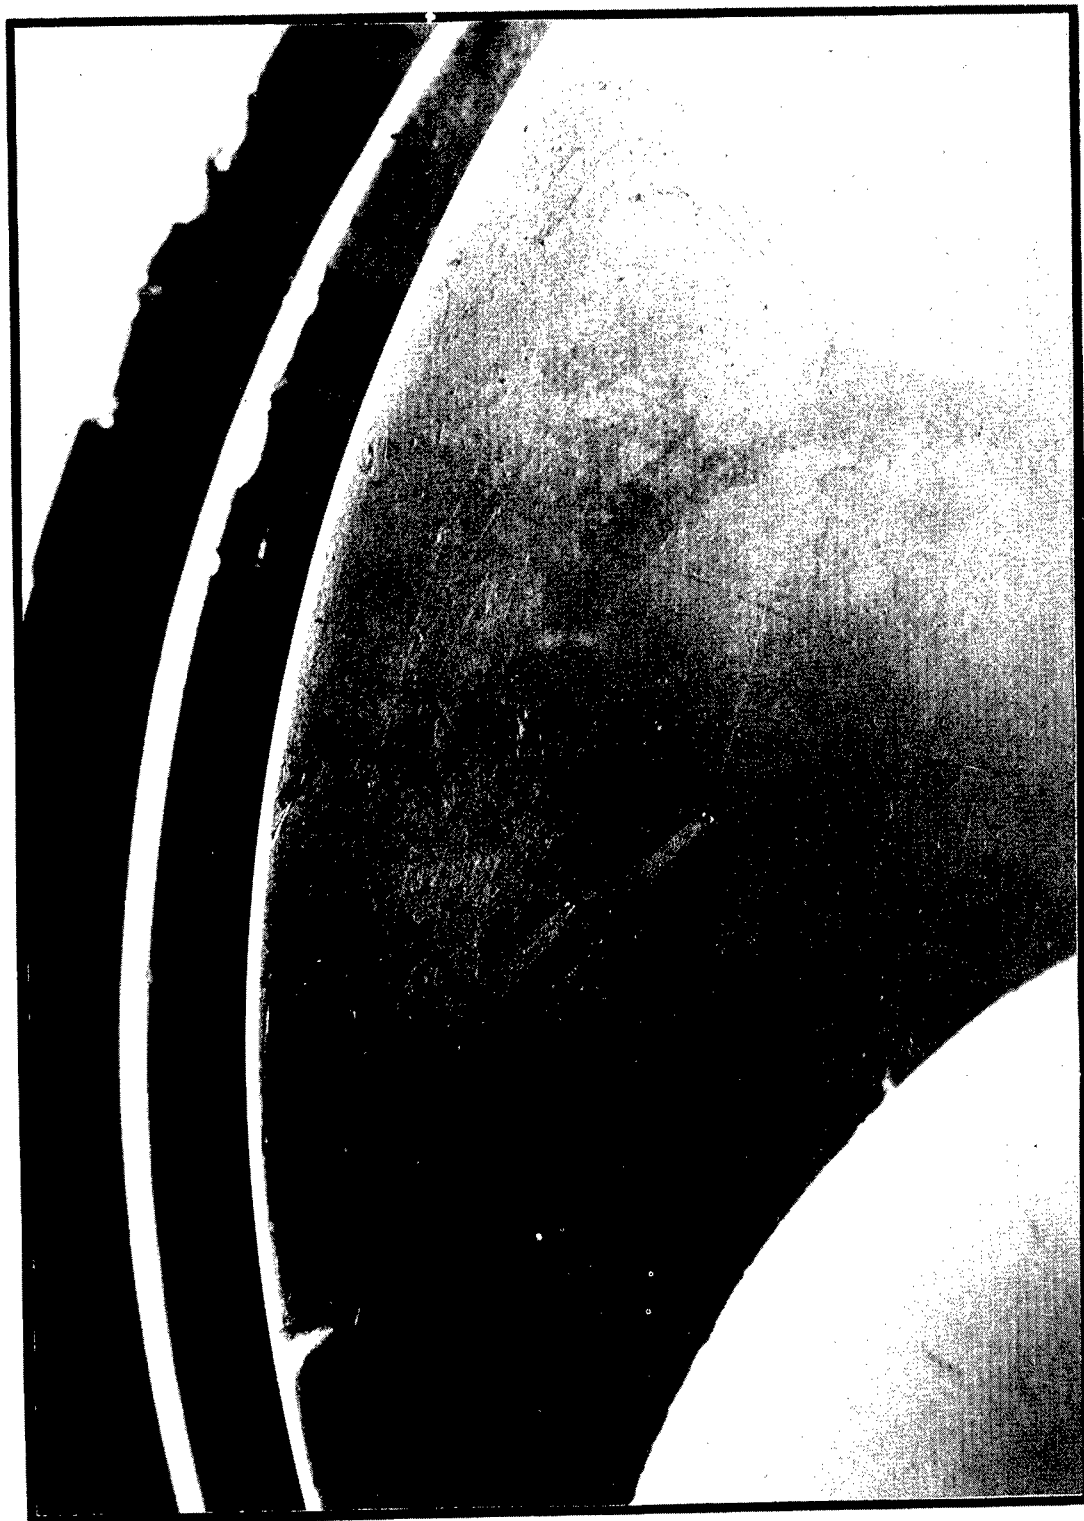
FIG 57

SECONDARY CAVITATION DAMAGE ON VANE 2

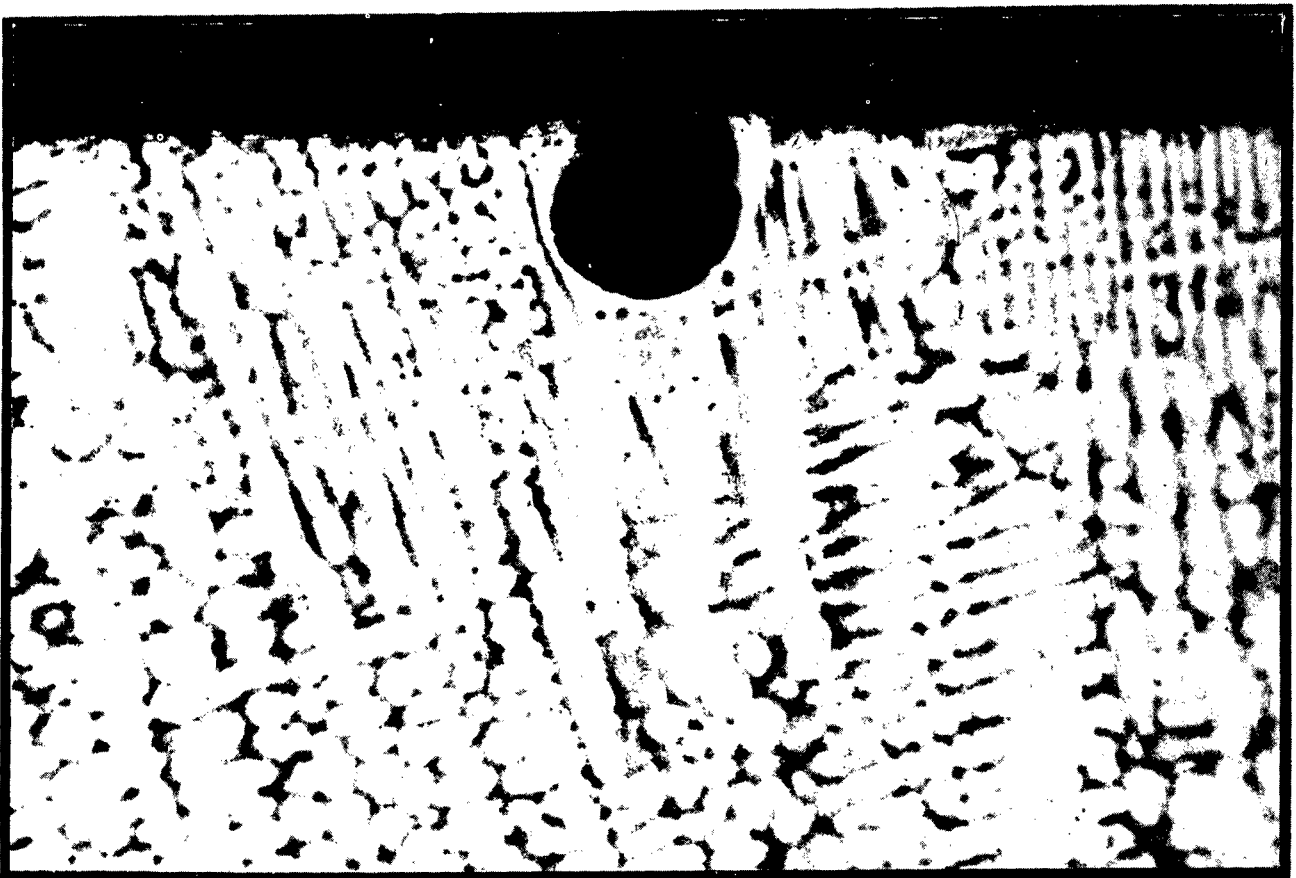
FIG 66

LARGE PIT OF FIG. 65 IN CROSS SECTION

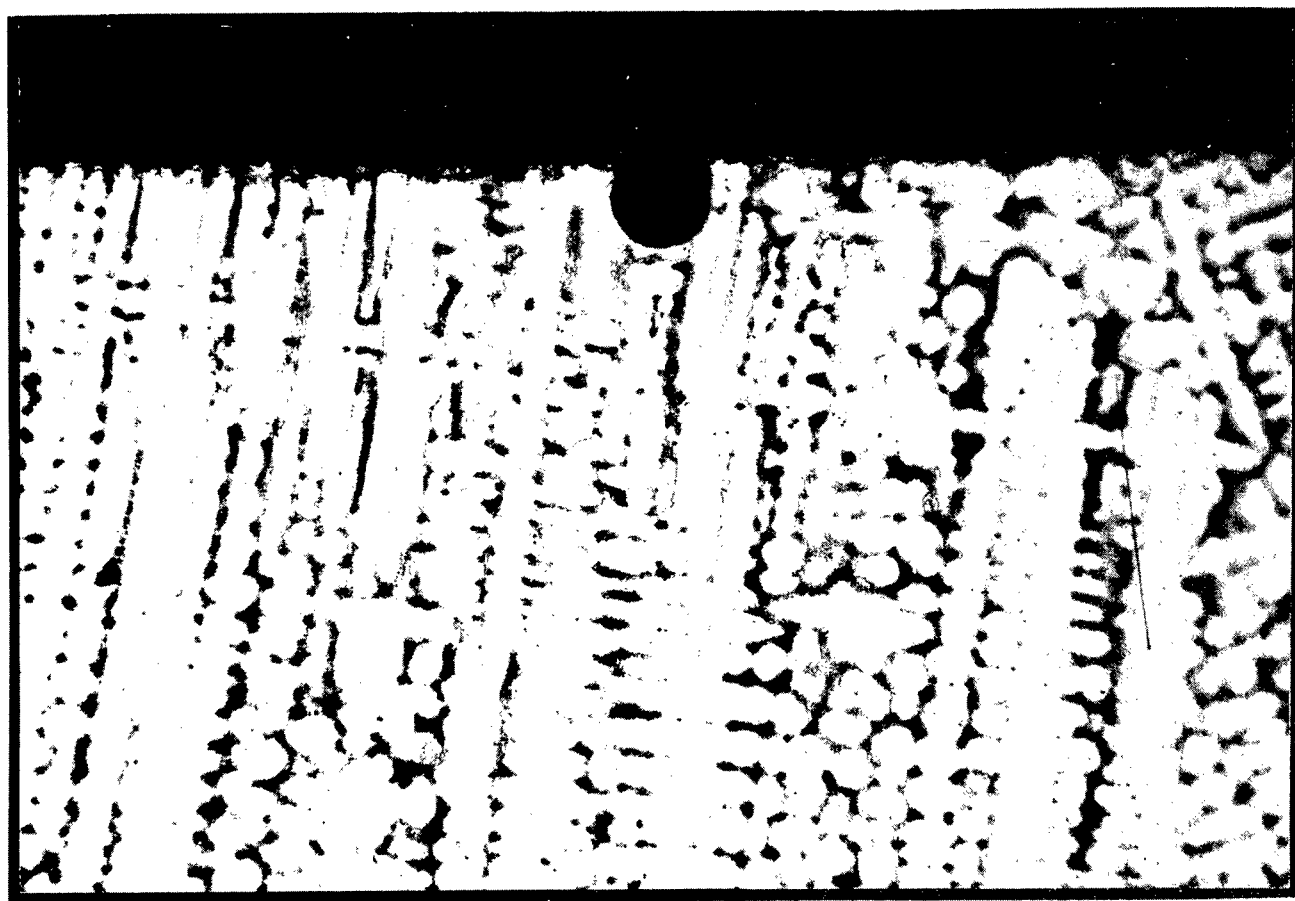
FIG 67

SMALLER PIT OF FIG. 65 IN CROSS SECTION

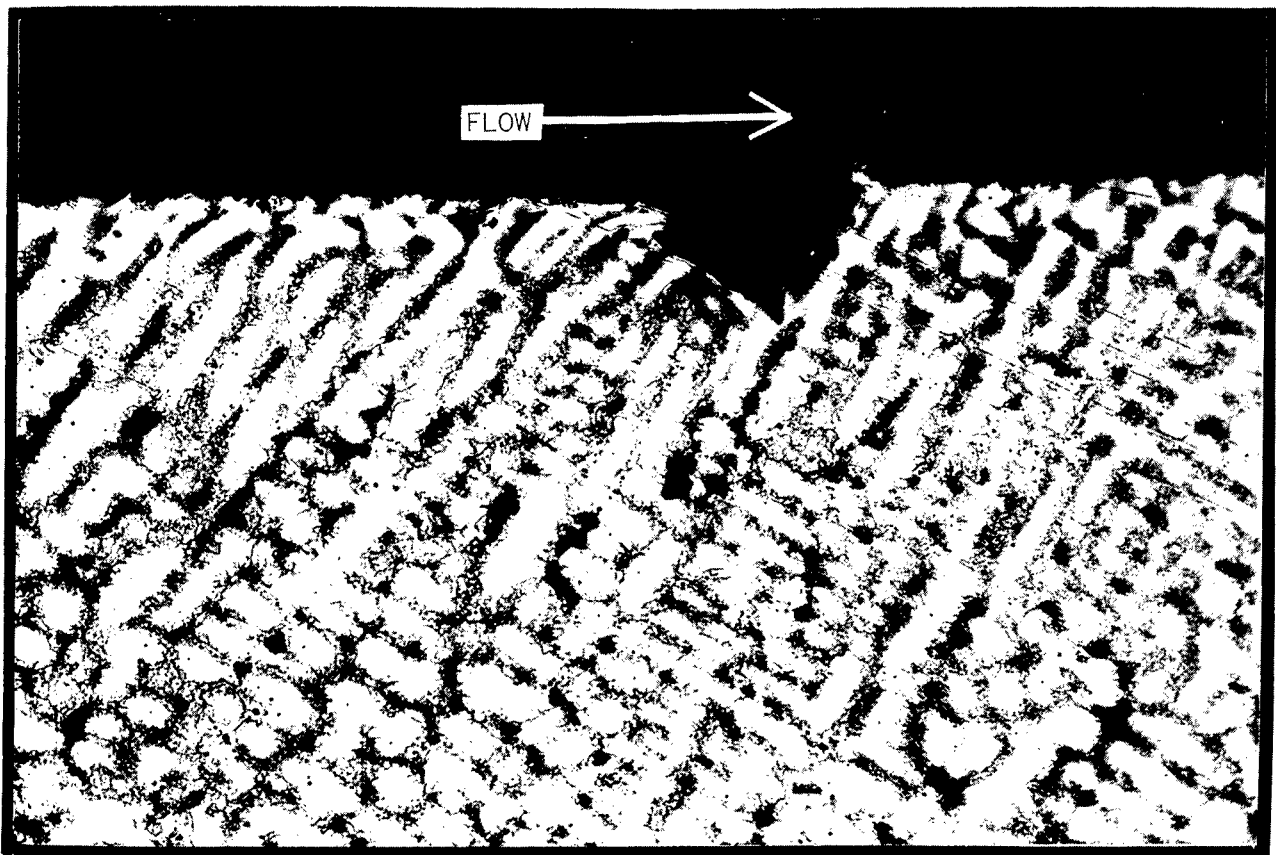
FIG 74

The test showed that the selected test conditions were too severe; they resulted in excessive cavitation damage. Several areas of cavitation damage were found; the most severe damage occurred on the pressure surface near the vane channel exits. The most severely damaged area was measured during metallographic examination to have a depth of penetration of 0.050 inch. Minor damage found on the inlet pressure surfaces was judged to consist of single event pits. The suction surface of one vane at the impeller inlet had cavitation damage induced by two small projections above the blade surface.

PHOTOMICROGRAPH OF PROJECTION CAUSING CAVITATION DAMAGE
